## American Integrated Resources, Inc.

Subject: Interior Moisture Investigation Report  
The Source Hotel  
6988 Beach Boulevard  
Buena Park, CA 90621

American Integrated Resources, Inc. (AIR) is pleased to submit this Interior Moisture Investigation Report for The Source Hotel located at 6988 Beach Boulevard in Buena Park, CA 90621.

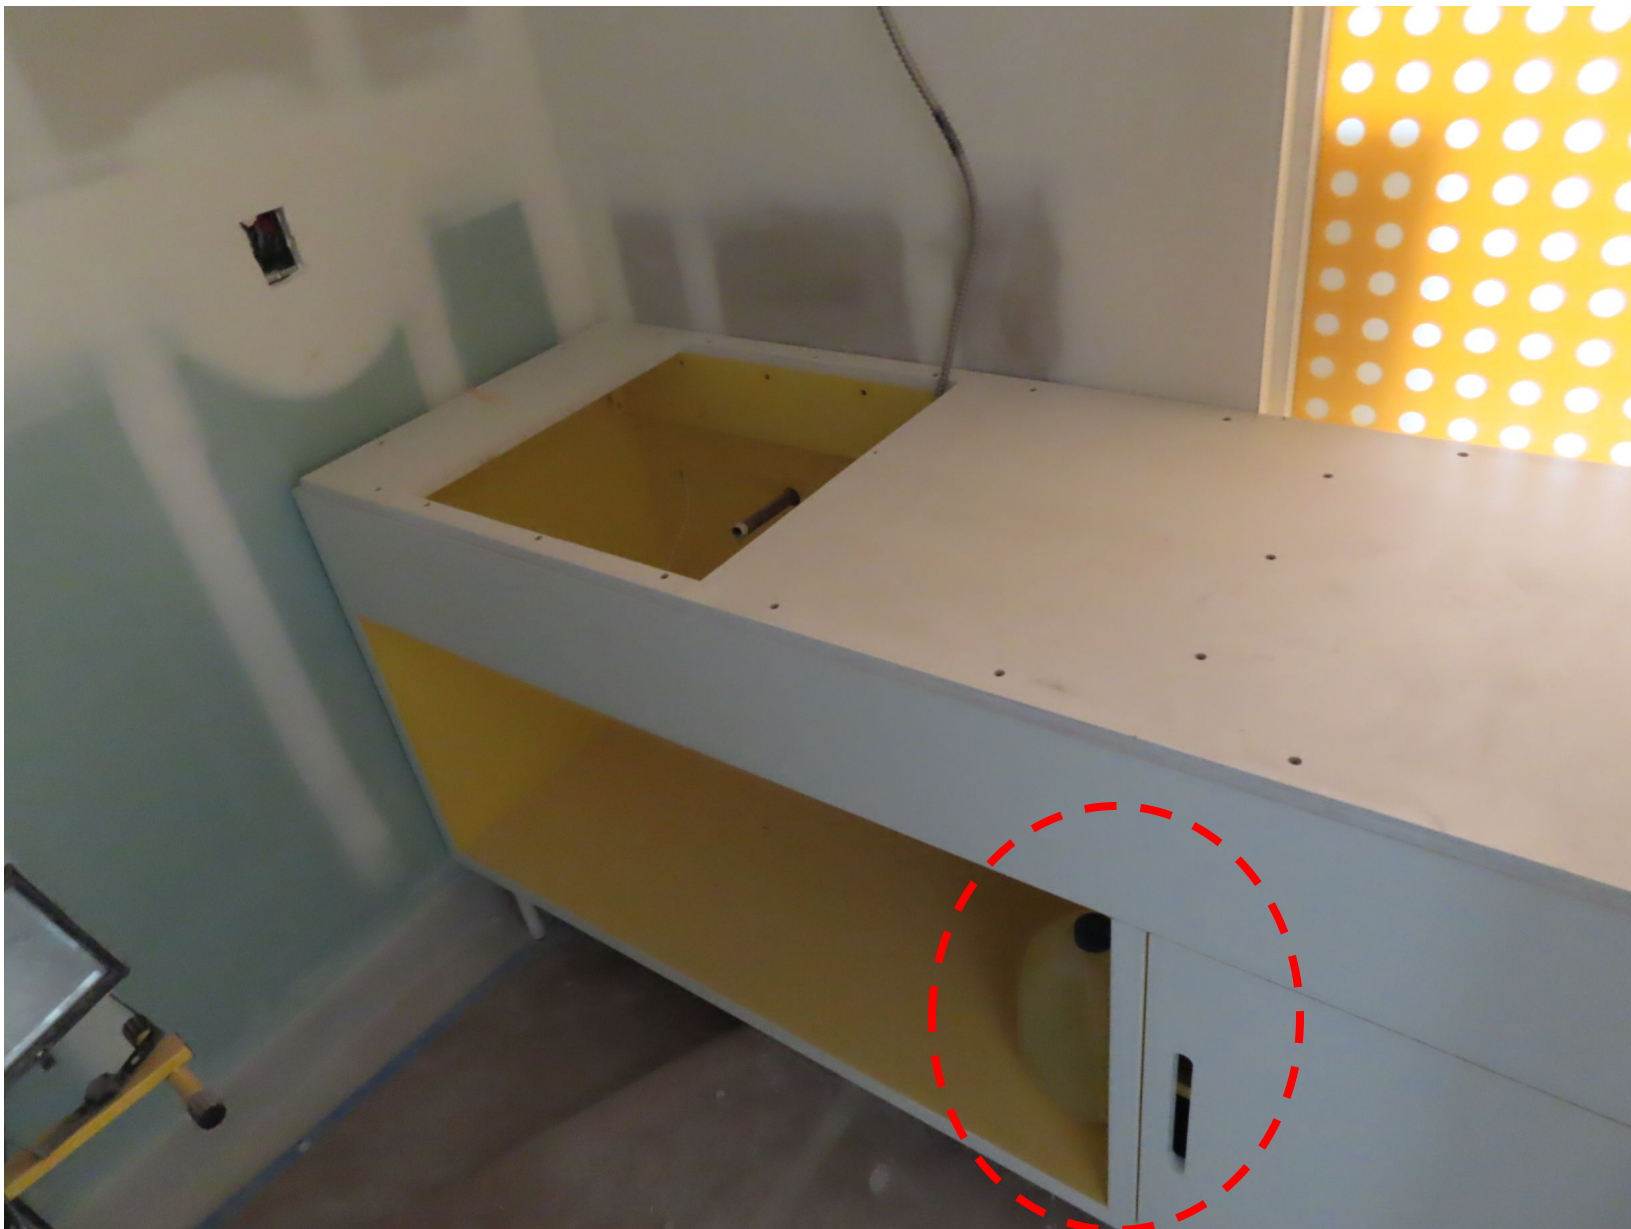
Unit 725  
Open  
Bath  
Cabinet

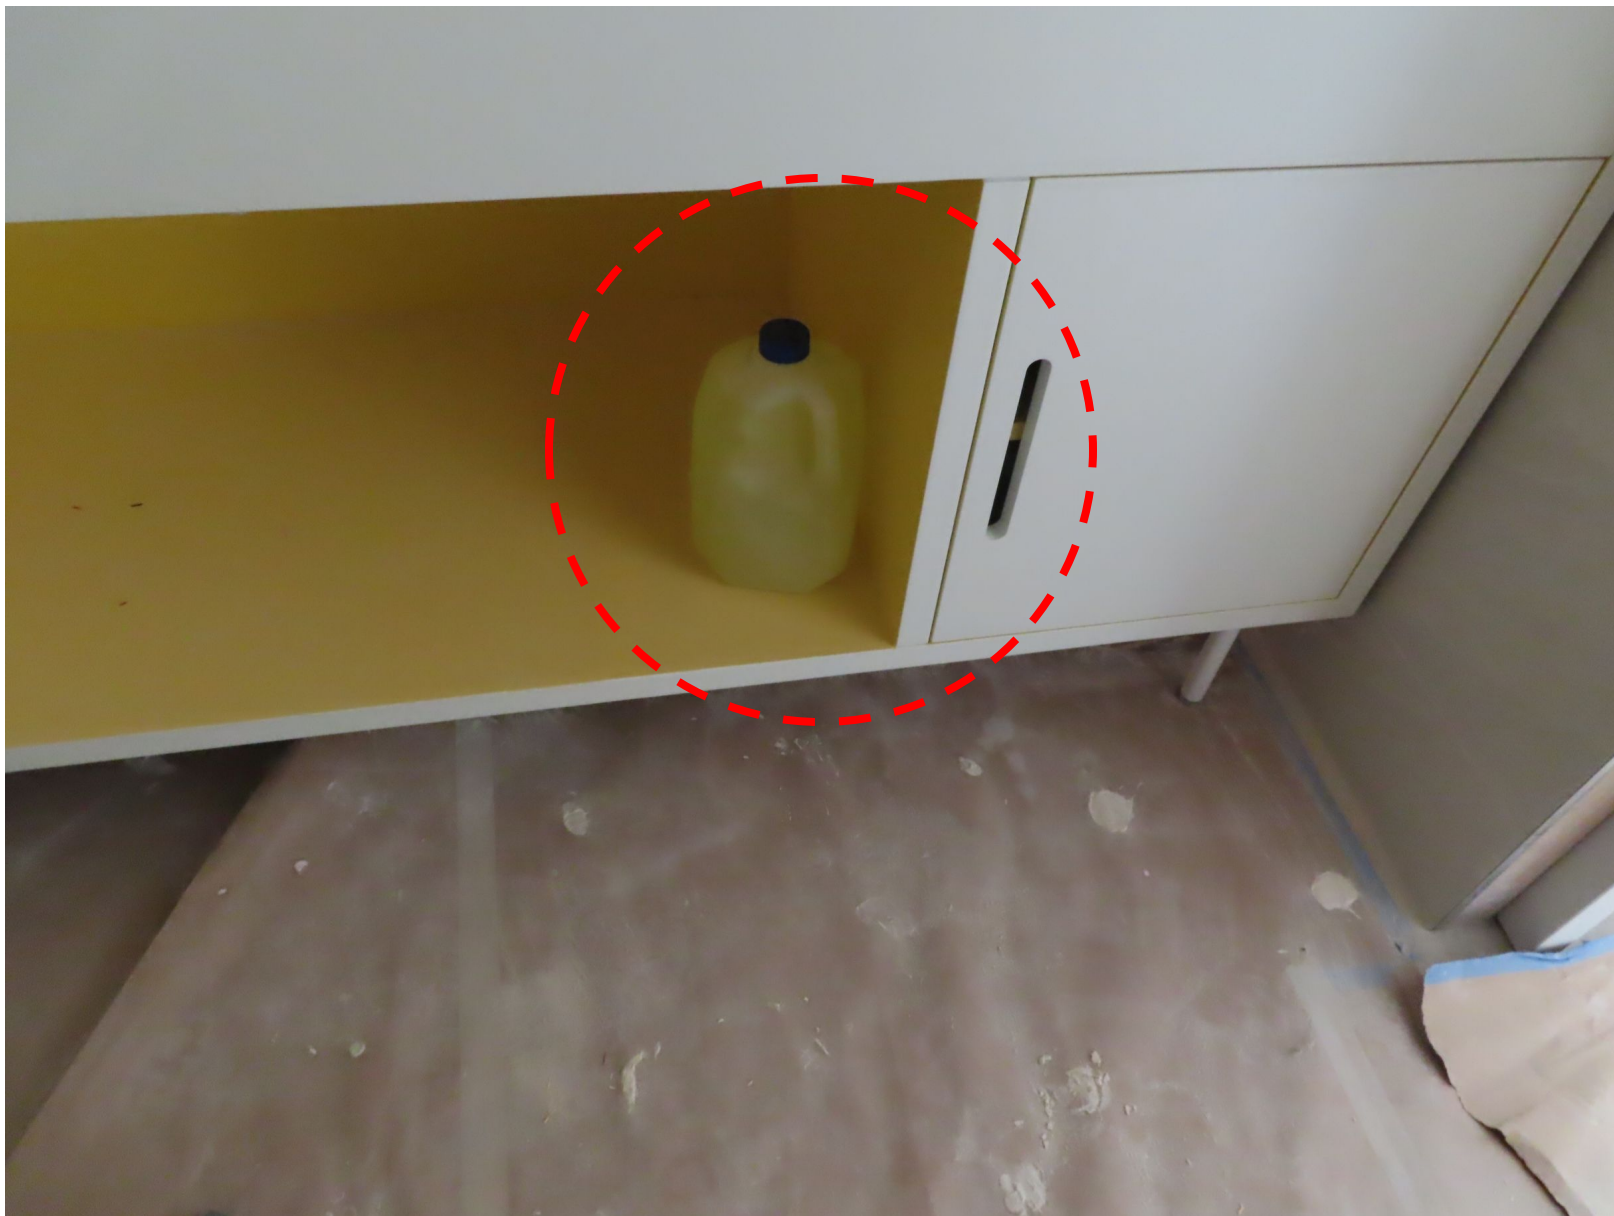
Unit 725  
Open  
Bath  
Cabinet

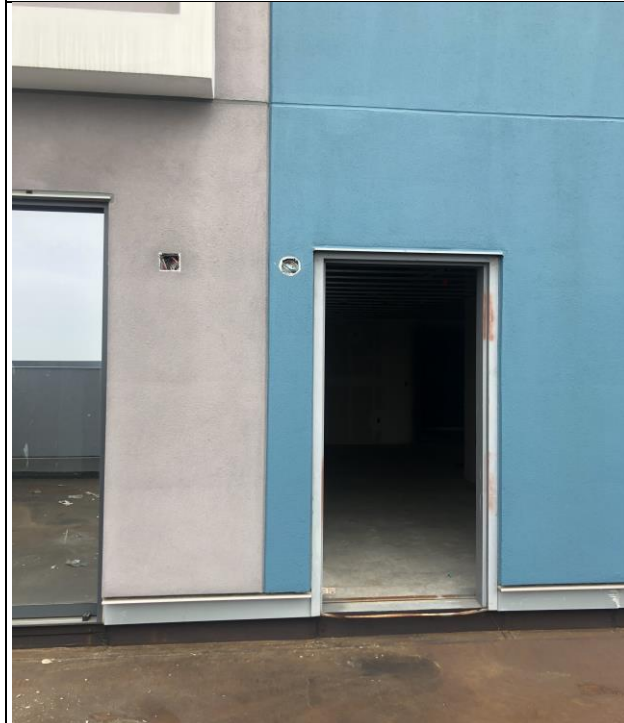
- The 4<sup>th</sup> floor exterior doors to the pool area were all missing allowing the elements to enter the building. However, on May 12, 2021 a construction crew was on-site reportedly to install the doors.

- It was also observed on the 4<sup>th</sup> floor pool area that the electrical junction boxes for wall lighting are exposed and uncovered. This could allow water intrusion to the building and wall cavities as well.

Missing door and open electrical junction boxes at pool area of the 4<sup>th</sup> floor

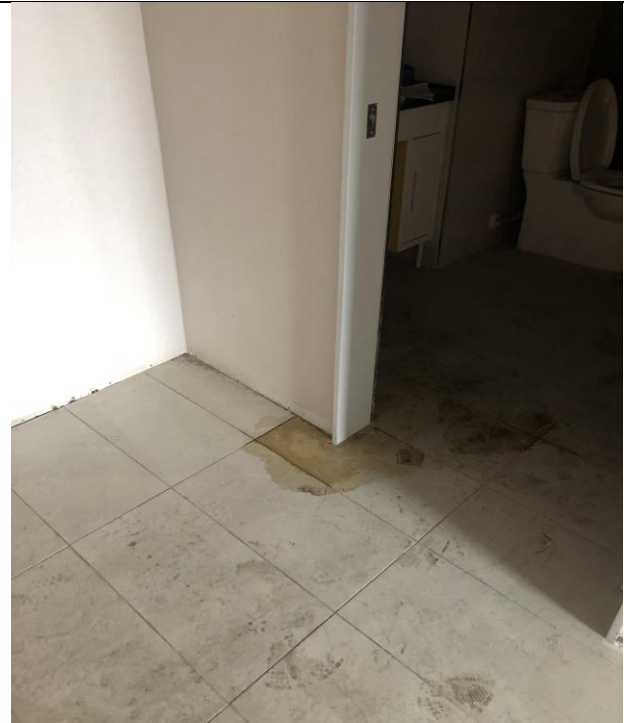
- A small water puddle was observed at the bathroom entrance in Room 429.
- The First floor was also found to be in a similar open atmosphere condition as the 4<sup>th</sup> floor. The doors however were in place but were wide open.

Minor water puddle in Room 429

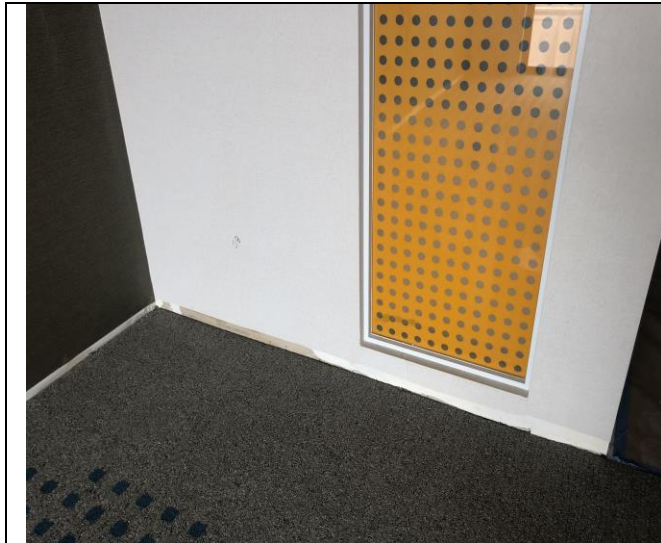
\*One reading of 0.8% was measured in Room 445 behind the bathroom sink wall. Although this level does not indicate an elevated reading, it was found to be higher than all the other readings and was therefore noted.

Slight elevated moisture reading in Room 445 wall behind the bathroom sink (0.8%)

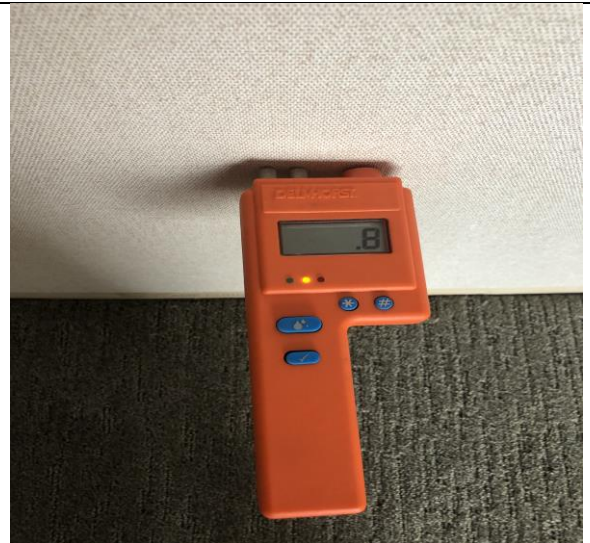
Room 445 behind bathroom sink

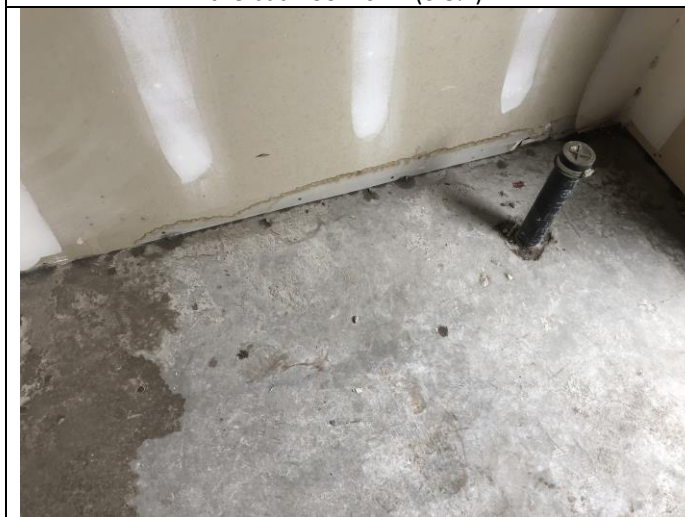
Water staining in the outside pool equipment room on the 4<sup>th</sup> floor pool area

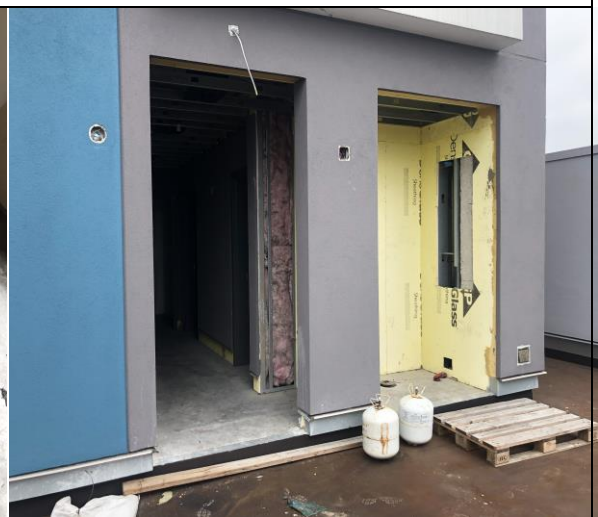
Open doorways and open electrical j-boxes at pool area of the 4<sup>th</sup> floor

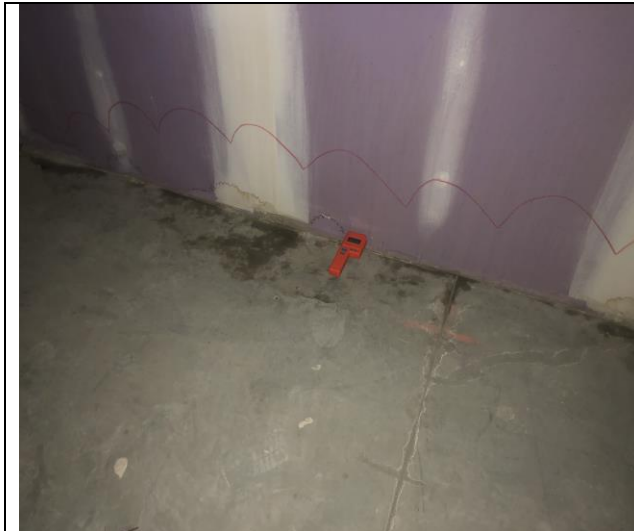
Minor staining on the purple board and concrete floor on the north-center rooms of the first floor (0.3 – 0.5%)

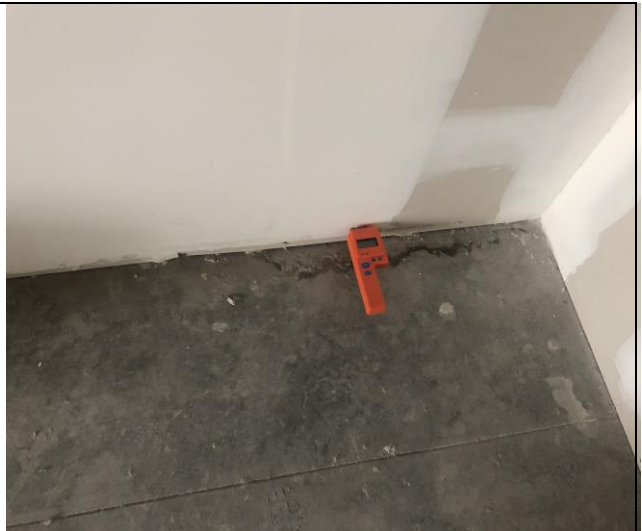
Minor staining in the north-center rooms of the first floor

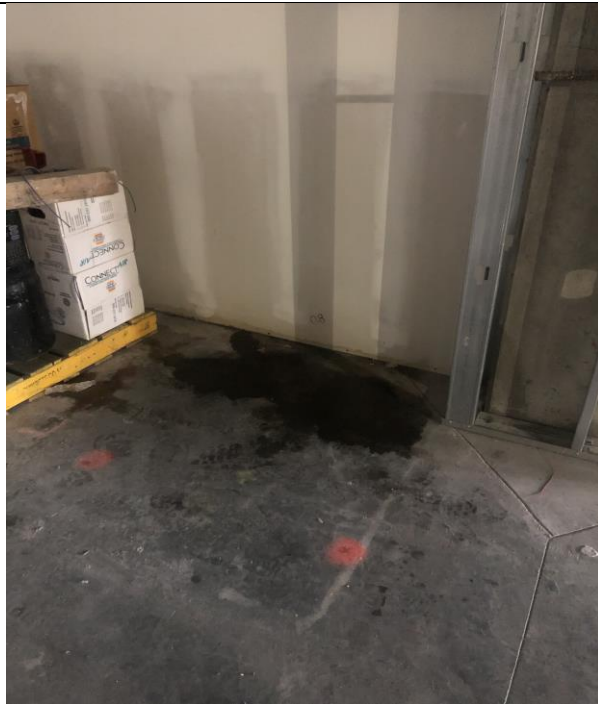
\*\*One reading of 0.8% was measured at the open westside of the first floor on the wall next to where a small amount of oily water has accumulated. Possible spill of some sort.

Slight elevated moisture reading and oily water at the open westside area of the first floor (0.8%)

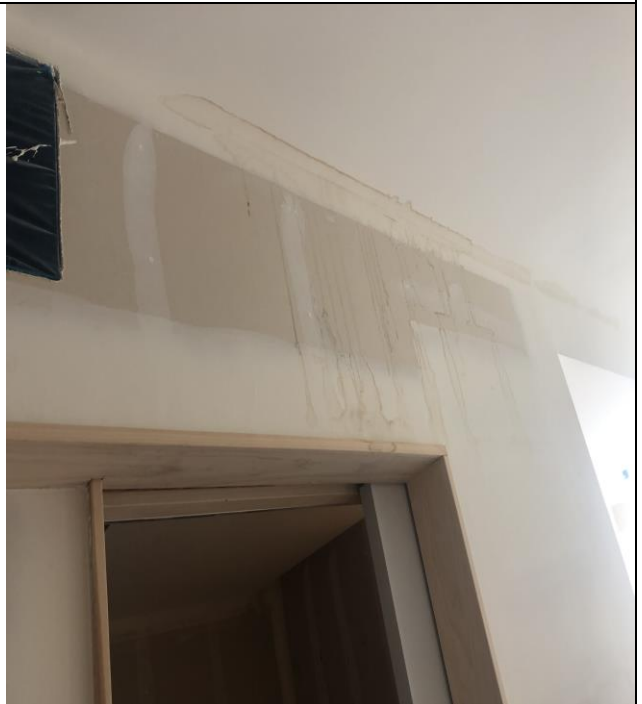
- Water staining possibly from a roof leak was observed above the bathroom entrance door in Room 738. The moisture reading however was 0.2 – 0.3% (normal).

Water stain above bathroom entrance in room 738. Possible roof leak (0.2 – 0.3%)
